Re: Bow Eye Strength Tests

On June 10, 2003, The Center for the Built Environment (CBE) conducted a series of tests on bow eyes provided by EPCO Products, Inc. Fixtures for each series of tests were fabricated in our machine shop to accommodate tensile, side pull, and edge pull on the bow eyes. The following photographs indicate fixture arrangement and typical failure for each type of test.

**Failure Loads for Bow Eyes      August 27, 2003**

**EPCO Products, Inc.**

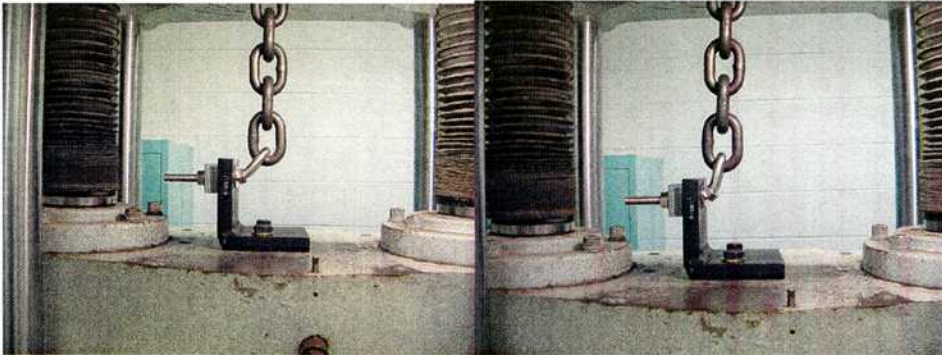
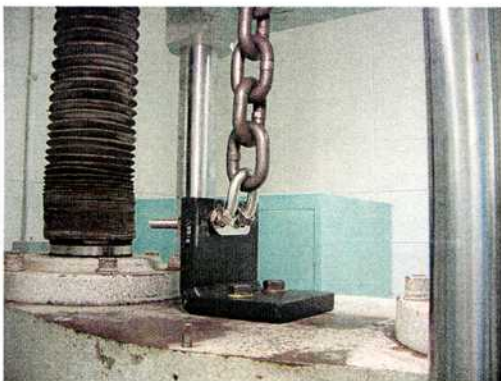
The values designated in **red** did not exhibit failure loads consistent with results of the other tests. Additional bow eyes were requested for these items for additional testing. Retest items, performed July 21, 2003, are designated in **bold type**. These results, **bold type**, can be used for side pull failure loads. The high failure loads of the 151-316 bow eyes in the side pull test resulted from direct contact of the bow eye nuts with the plate fixture, with a resultant load transfer to the plate. The CBE requested 2 additional 151-116 bow eyes to verify the failure mechanism. These tests were performed on August 18, 2003, with results shown in **blue** in the table. The fixture could not be modified to accommodate the loading and deformation. During the side pull test, the bow eye deformed to a vertical position, resulting in contact of the nuts with the test fixture long before failure occurred. The load was transferred to the fixture at approximately 5000 lbs. This load and resultant deformation would simulate an "in-use" condition, not a true

material failure as in the other tests. Depending on the material that the bow eye is attached, failure may occur in this material before bow eye failure. The average failure load of 32,300 lbs will be reported under the preceding condition of failure. The following photographs illustrate the loading and failure condition.

Tensile tests results and edge pull test results correlate to expectations of material behavior for a single test situation. Side pull test results are not as conclusive, even with a second series of tests. However, with an appropriate factor of safety, side pull results can be used.
